# Progress Report 7

## Week 12

### December 5th

Glachbeg Croft – will be opening to provide education programmes in the Spring of 2005. Glachbeg Croft is not just an environmental education centre. will be able to provide curriculum support across most areas of study. Programmes will be constructed with you to be a fun, exciting experiential learning event.

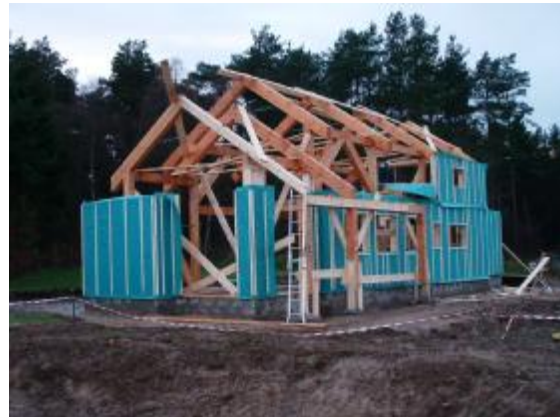
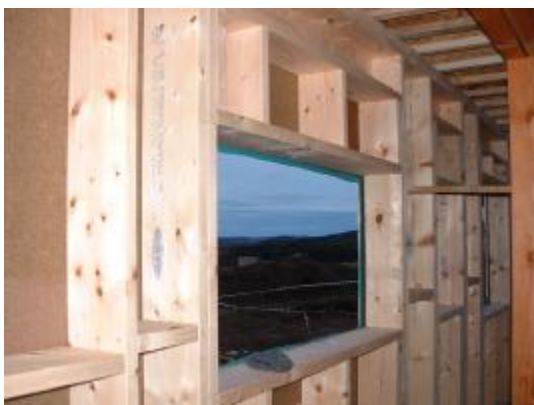
Now the frame is up we have to start building the walls. The “Soleplate” made of Larch is attached to the block wall to form the base onto which the walls will be built. *Question: Why do we use a hardwood sole plate?*

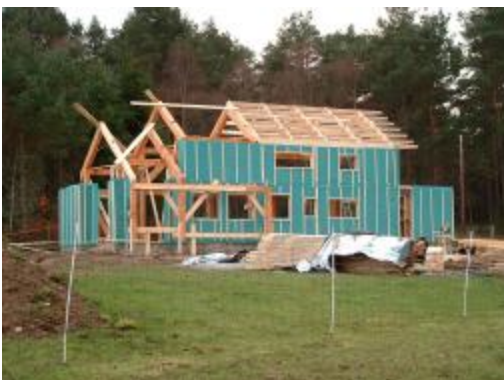
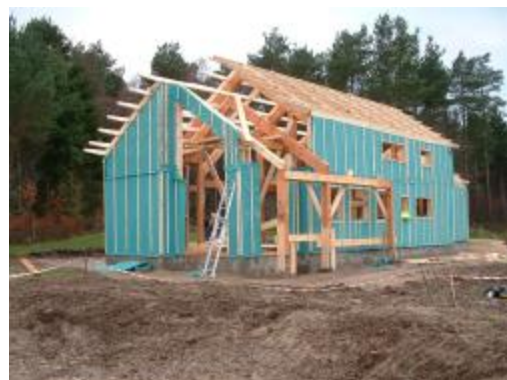
Now the frame is built on the roof. This all has to be very strong as the grass roof will weigh many tones. This is why the building has a frame. The frame will support the weight- not the walls. *Question: All of the timber has not been treated with chemicals- what are the advantages and disadvantages of this?*
